GROUP

FAIR WEAR & TEAR GUIDE

AMSTERDAM, MAY 2024

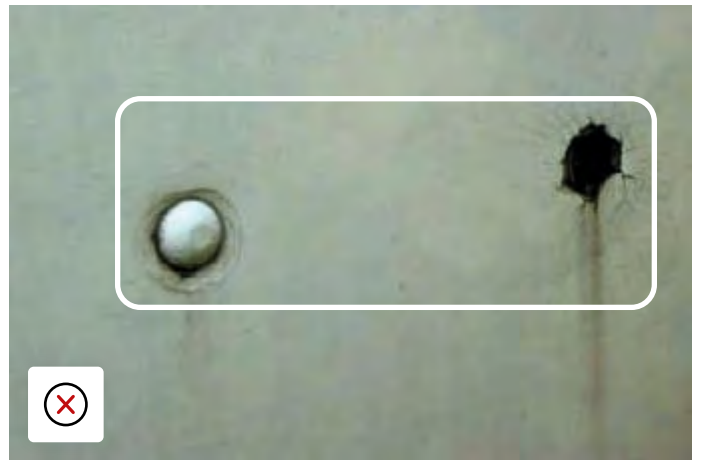
Bolts through GRP side panels.

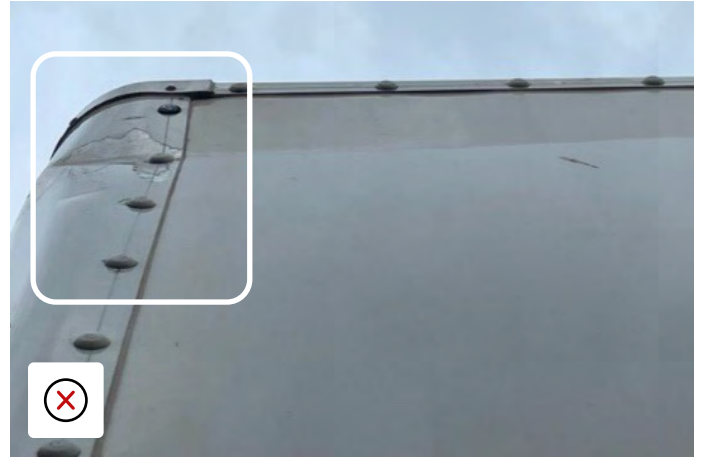
Corner post damaged due to impact with surface paint removed.

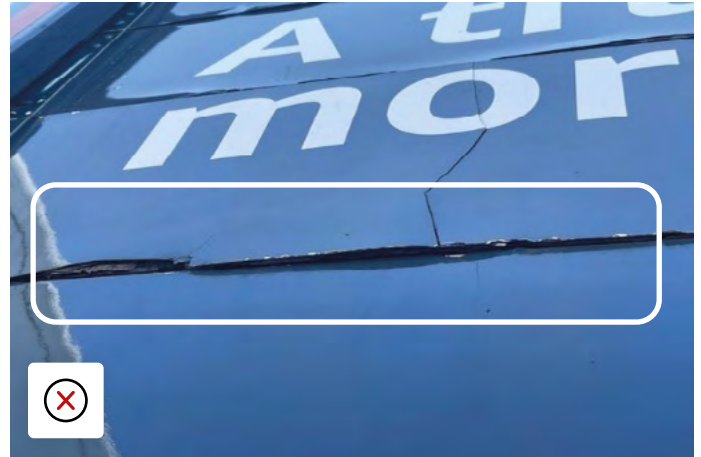
Door panel on roll shutter cracked due to impact

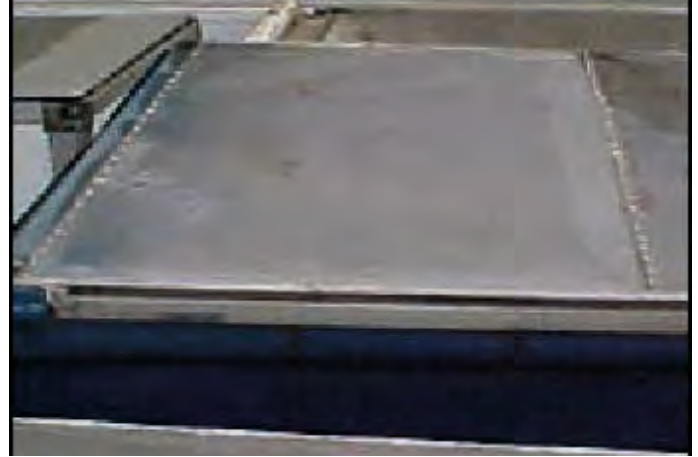
Splice:

- Remove full width section, replace, apply silicone sealant and secure with 3/16 or 5mm “blind rivets”.
- Can only make 2 splices creating a maximum of 3 separate roof sections.
- Patched area must be from behind damaged section to the nearest header (front or rear). If a roof is holed behind an existing spliced section, the repair must still be from behind the damaged area to the nearest header. As such the existing splice would be replaced at our expense.

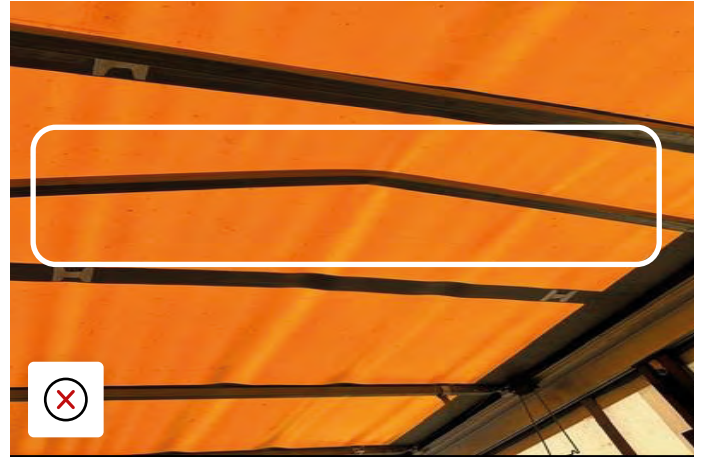
Edscha roof bows bent due to weight imposed from above.

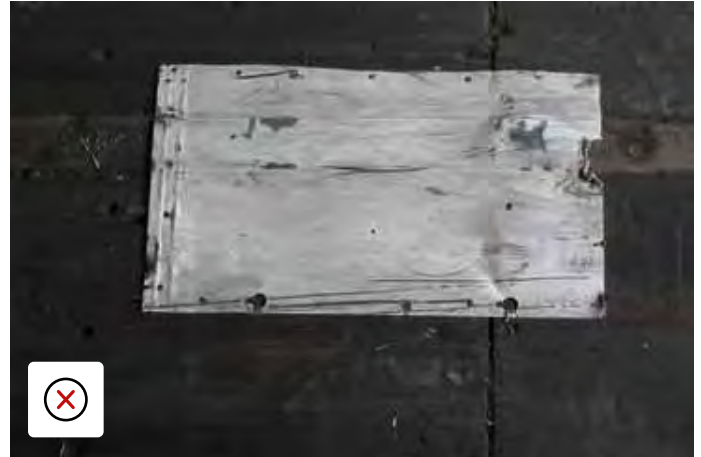
Metal plate over damaged floor section.

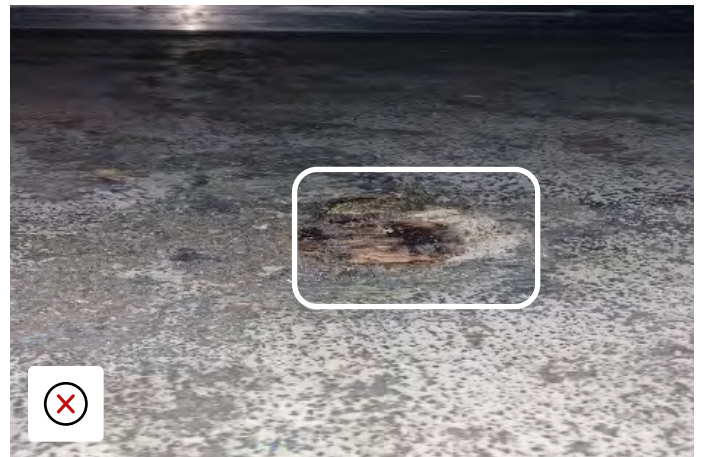
Resin floor protective coat holed & floor board beneath exposed

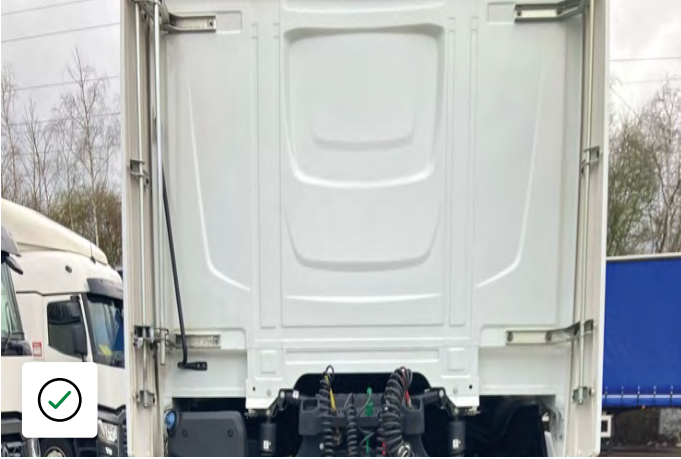
Cab in satisfactory condition

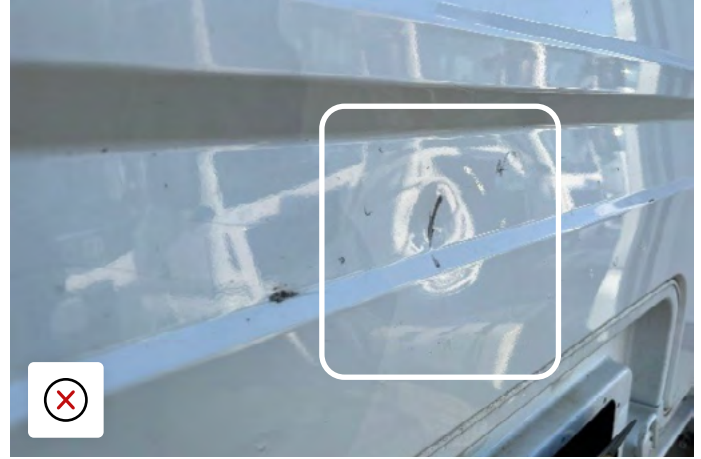
Impact damage to rear of cab causing crack

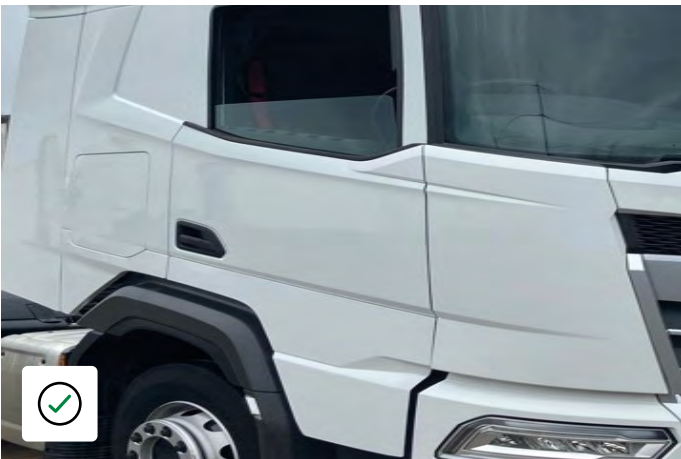
Door free from any damage

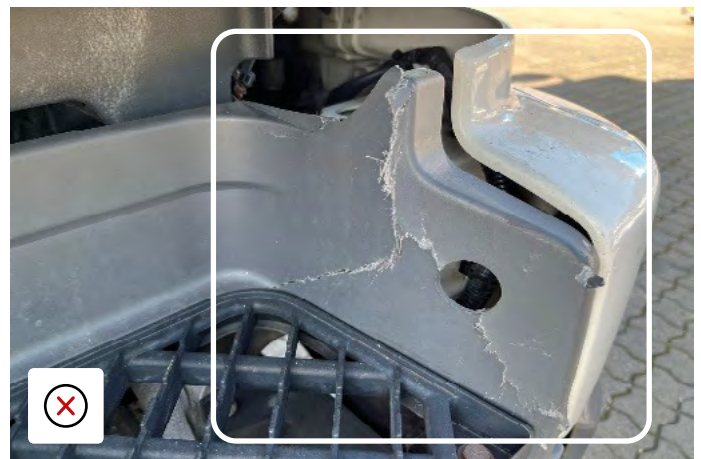
Step support structure unsafe due to impact

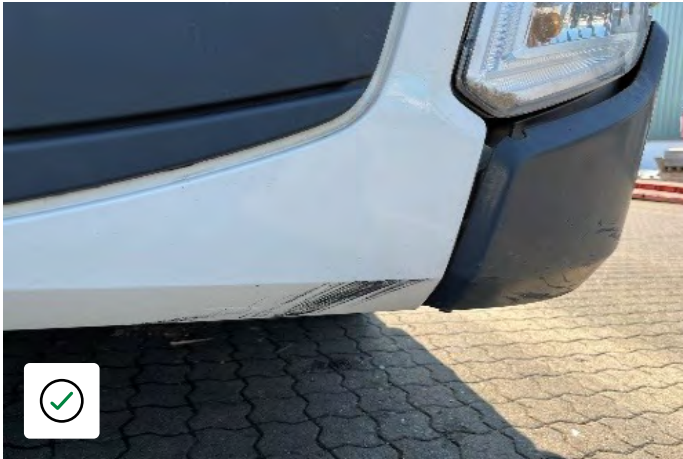
Minor scrape - no damage to the structure

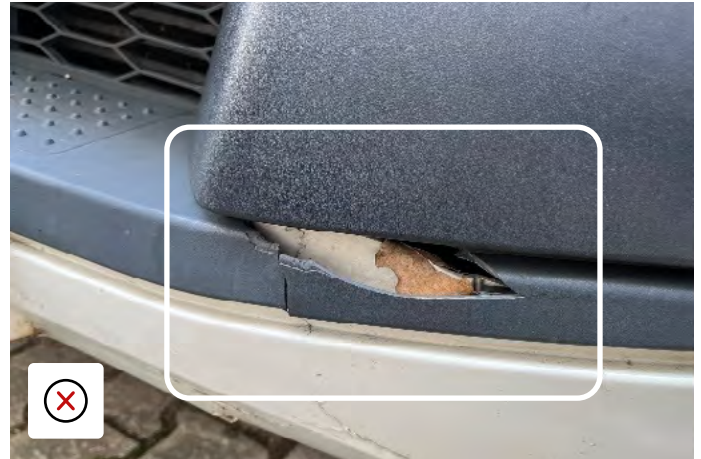
Major impact - bumper not fit for purpose

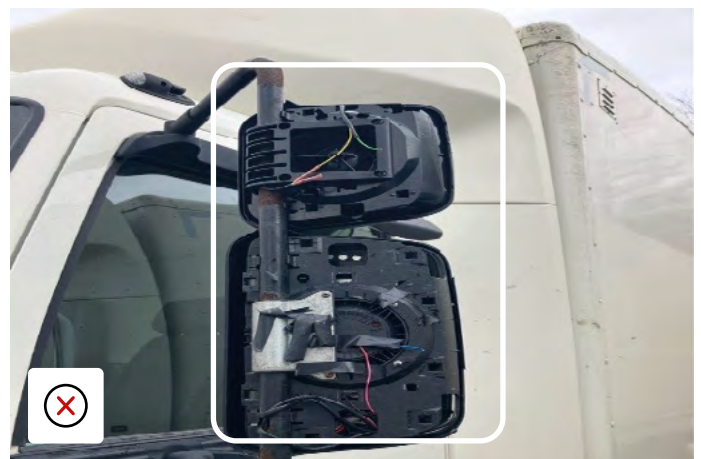
Mirror backing completely missing

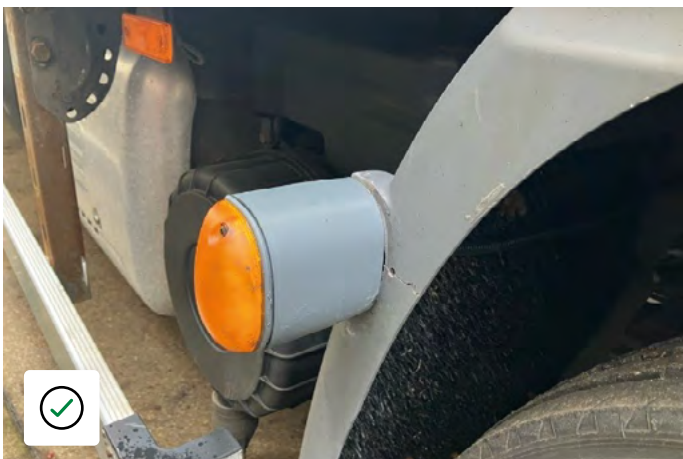
Side repeater & mounting in acceptable condition

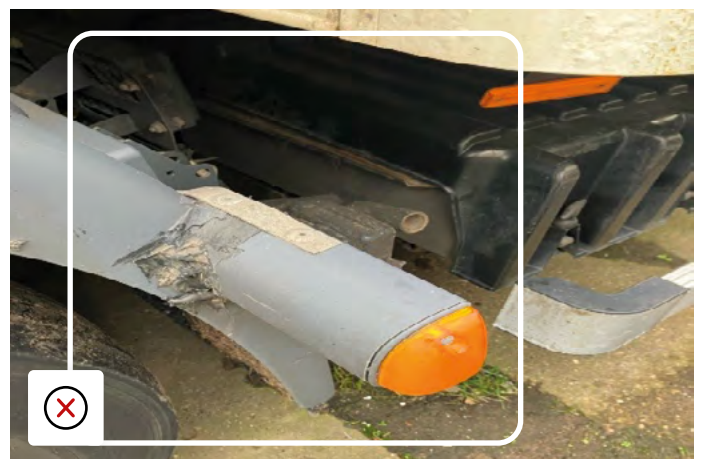
Substandard repair to side repeater mounting

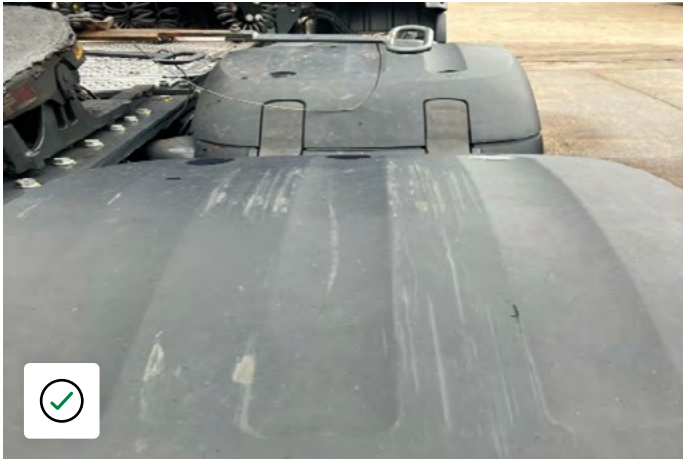
Small scuffs on wing top - still serviceable

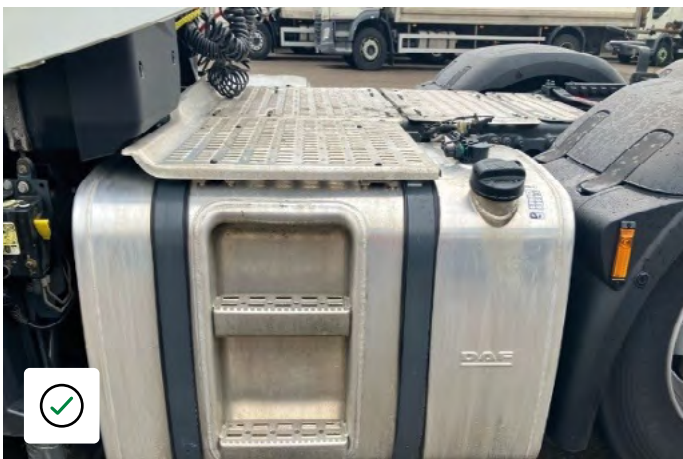
Fuel tank in reasonable condition

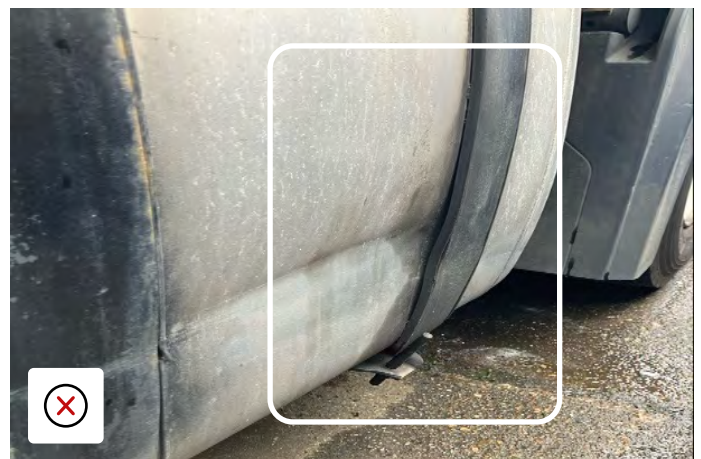
Fuel tank has been impacted & left large scrape

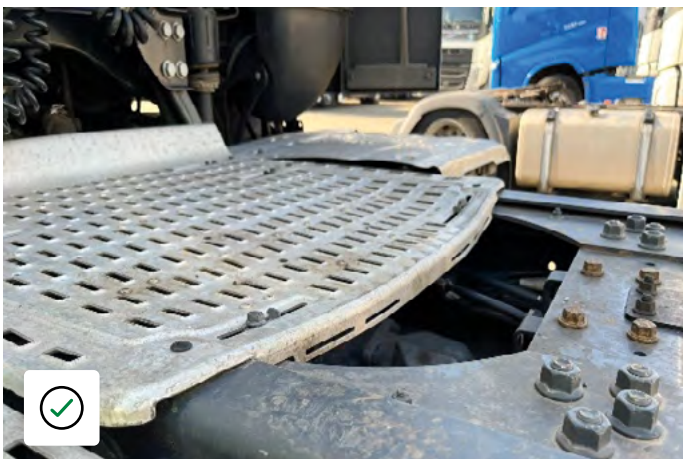
Minor deformation through normal wear & tear

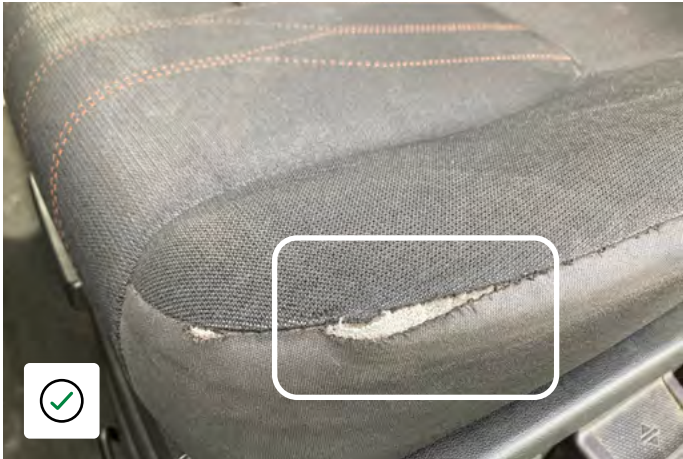
Minor scuffing to seat cover due to normal usage

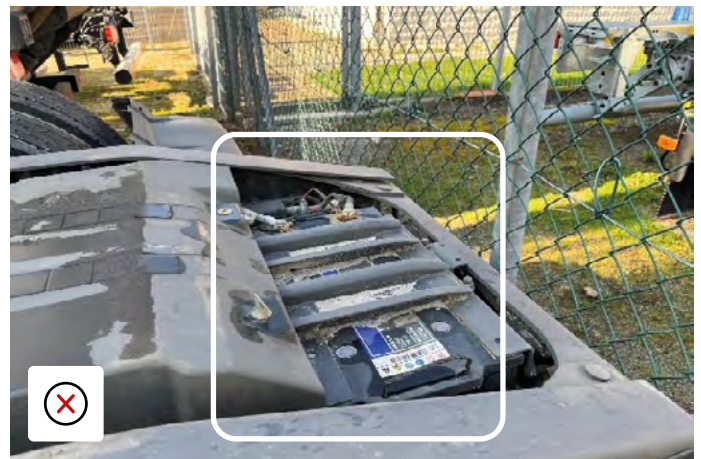
Battery cover missing - exposing battery to the elements

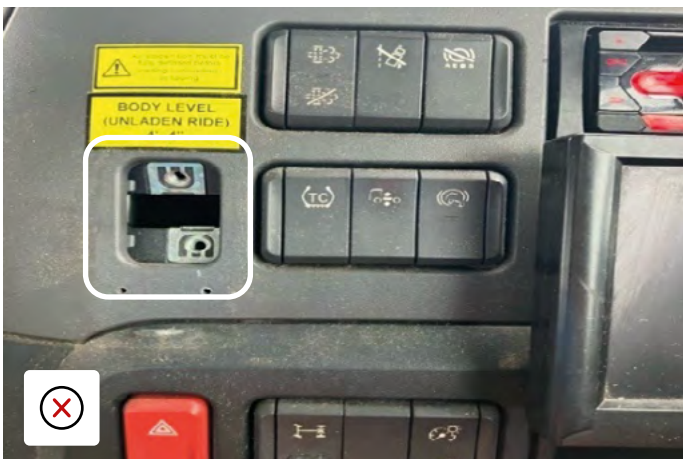
Screw holes in dash & trim missing

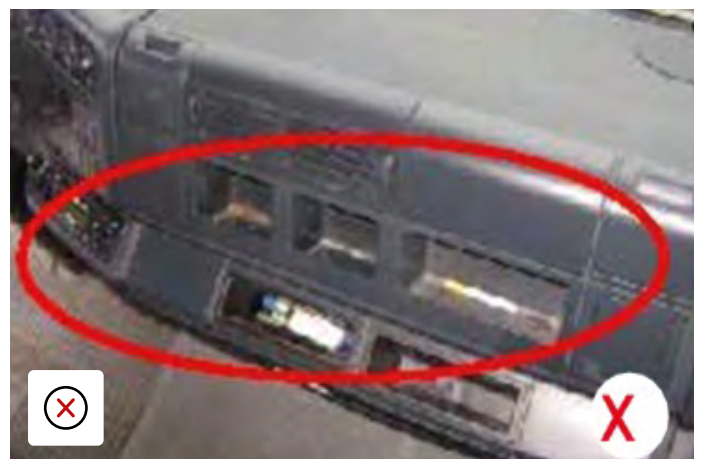
Blanking covers missing

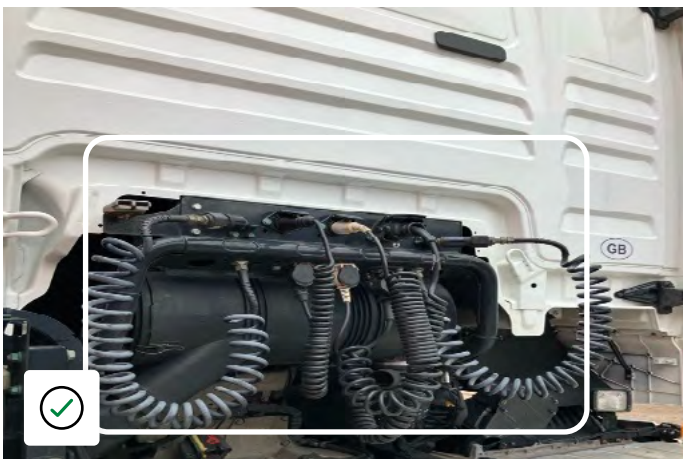
Suzie couplings in good condition & correctly stored

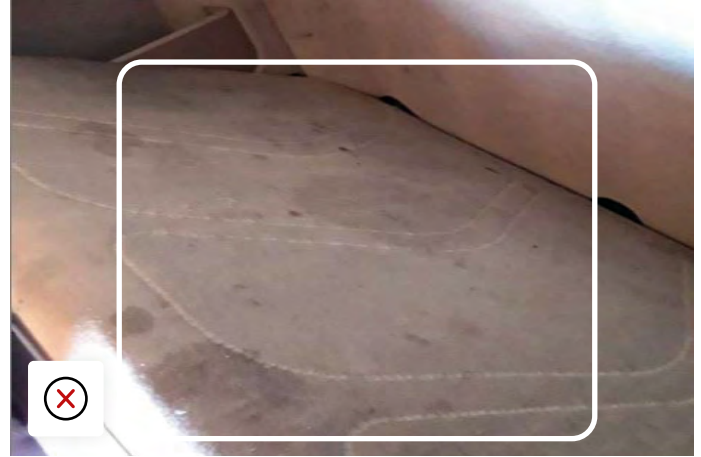
Heavily soiled mattress in a non-acceptable condition

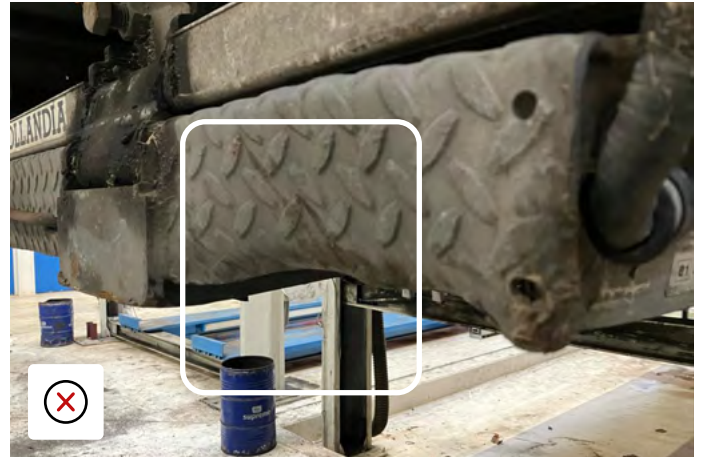
Platform impacted at a critical section - requires repair

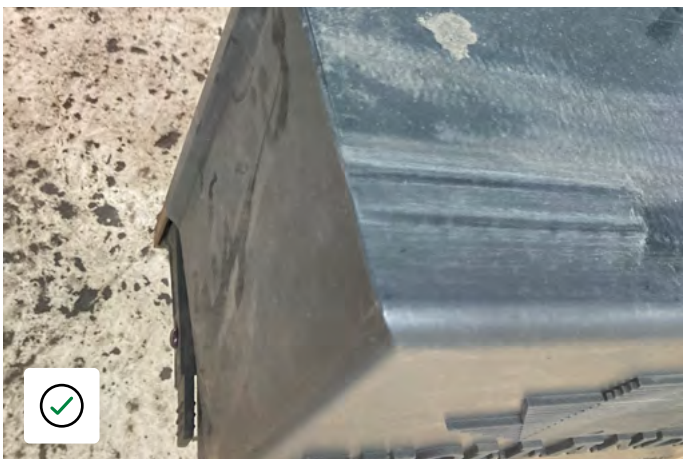
Cover with minor scratches

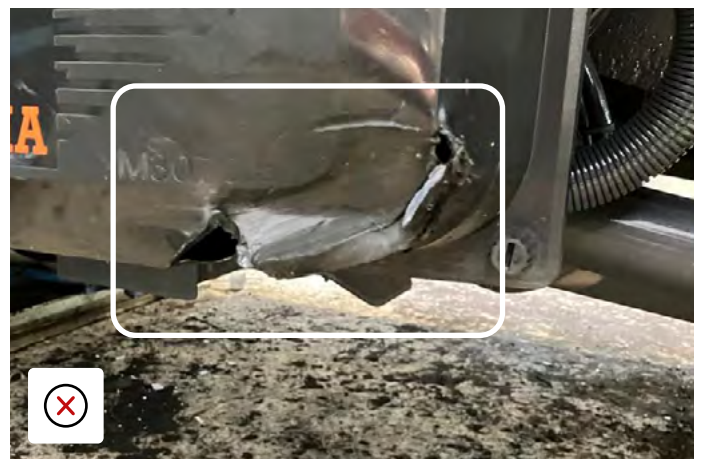
Cover broken - requires replacement

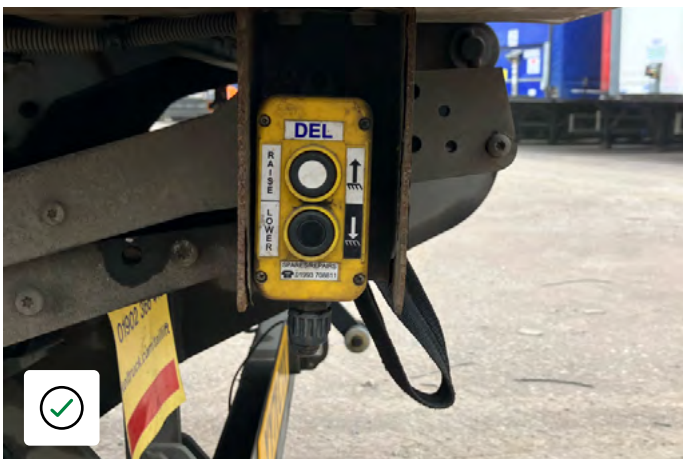
External switch present & operational

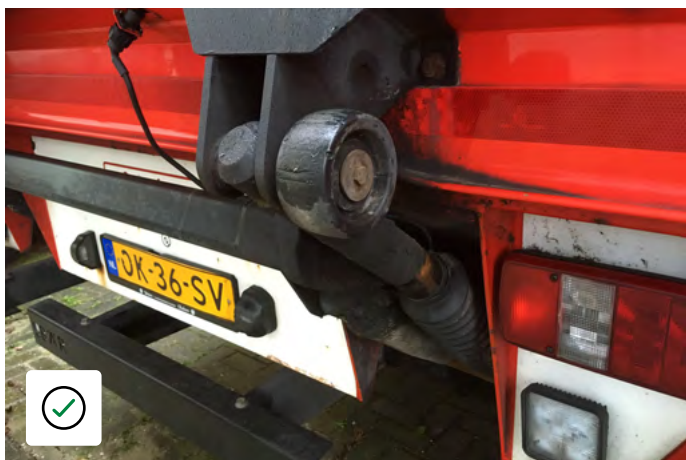
Platform roller with minor wear and tear

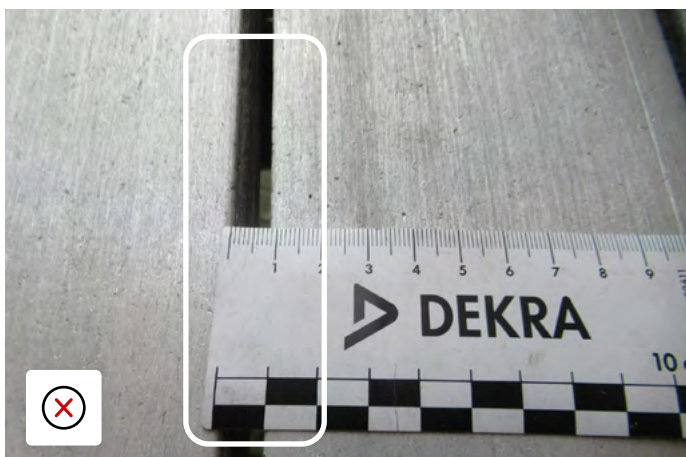
Floor bars spread and not safe for transport - goods can fall through the floor

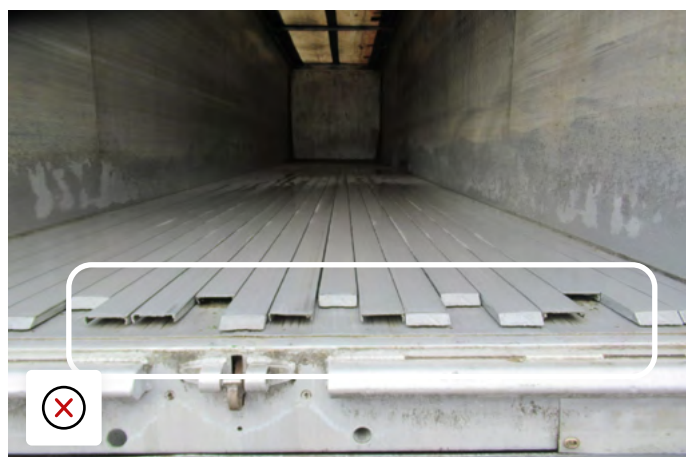
Bar edges are missing - goods can fall under the floor

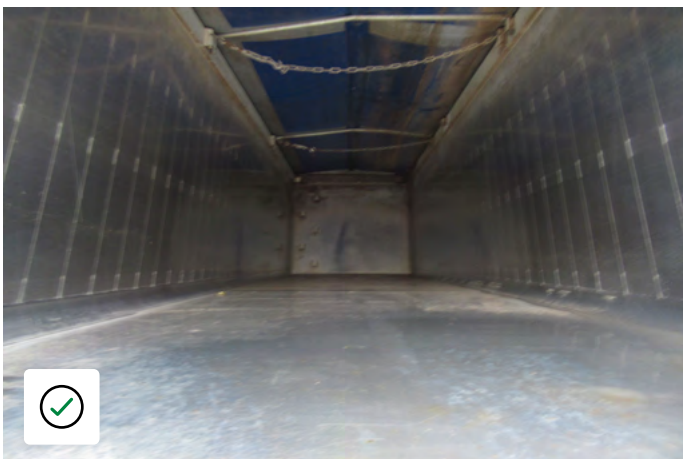
Floor in acceptable condition

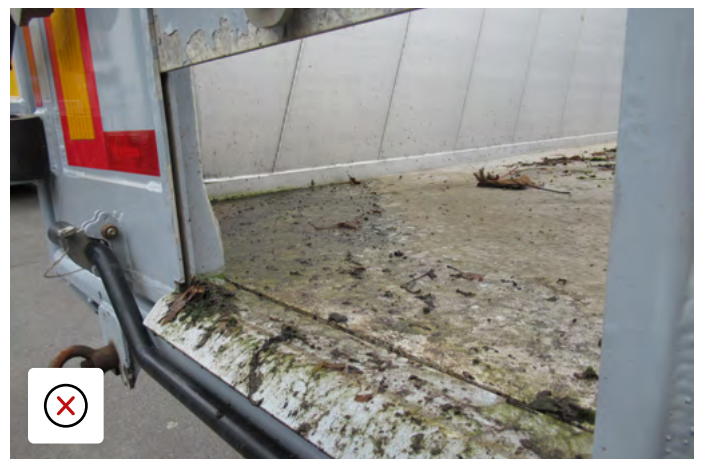
Floor requiring cleaning

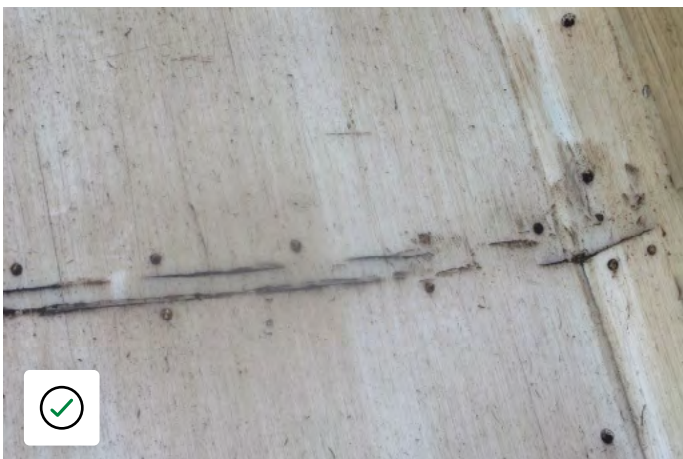
Floor protector with minor scuffs - fair wear & tear
